info on the bad sonic

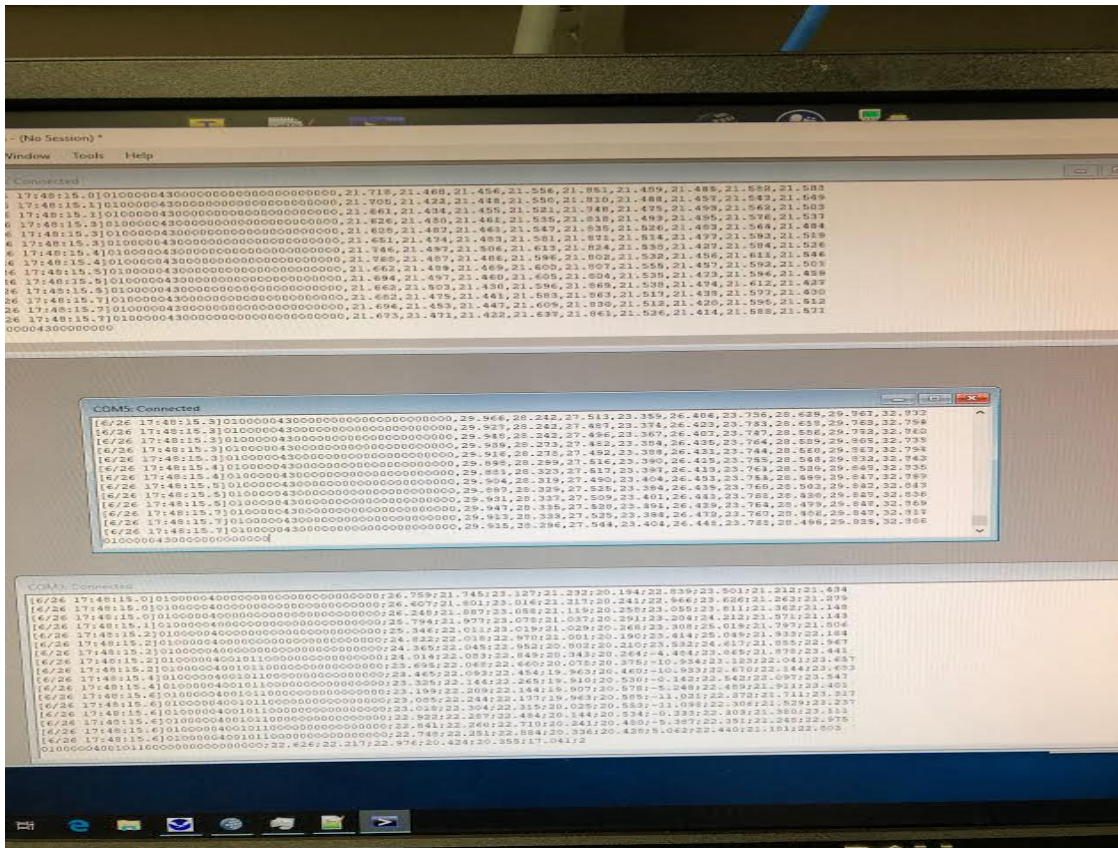
I haven't had a chance to inspect any spectra, but I ran 3 instruments, including the one with the increased MTD parameter under a hood for a half hour or so in the lab at ~ 23 C. The x,y,z wind calculations for each were well within spec in terms of both the mean offset from 0 and the noise level (L). I'm curious about the absolute temperatures, though. MTD=5 resulted in many rejected samples from the instrument we have discussed. An example of the radial temperatures (OI=4) from this instrument is shown in the middle panel of the image attached. The individual estimates range from 23 to 32 C. You can compare this to the samples in the panels above and below from the other two sonics (with MTD=5), which are both closer to the ambient air temperature and have less variation between the components. During the hood test, the mean sonic Temps were 29.1, 24.5 and 22.4 C. Again, the noise characteristics (L) were good (0.011-0.016 C). I don't see anything in the new manual about calibrations for sonic temperature: I recall that in older models, the user calibrated it but of course, for the EC application the noise in T is more important than the mean bias. Since L for T is in range, the variability amongst the components and the mean bias appears stable. My question is, given that the noise characteristics are small and the winds are within spec, is there any reason to be concerned about the fact that the radial temperatures are both biased and variable in this instrument, or is it best to just relax the MTD threshold and rely on the uncertainty and L metrics, as well as verify the spectra look realistic?

Thanks. The MTD parameter did address this issue. I've set it to 7 C, as you suggest.
