Observations of Licor Issues  
Stratus Cruise  
October 2007

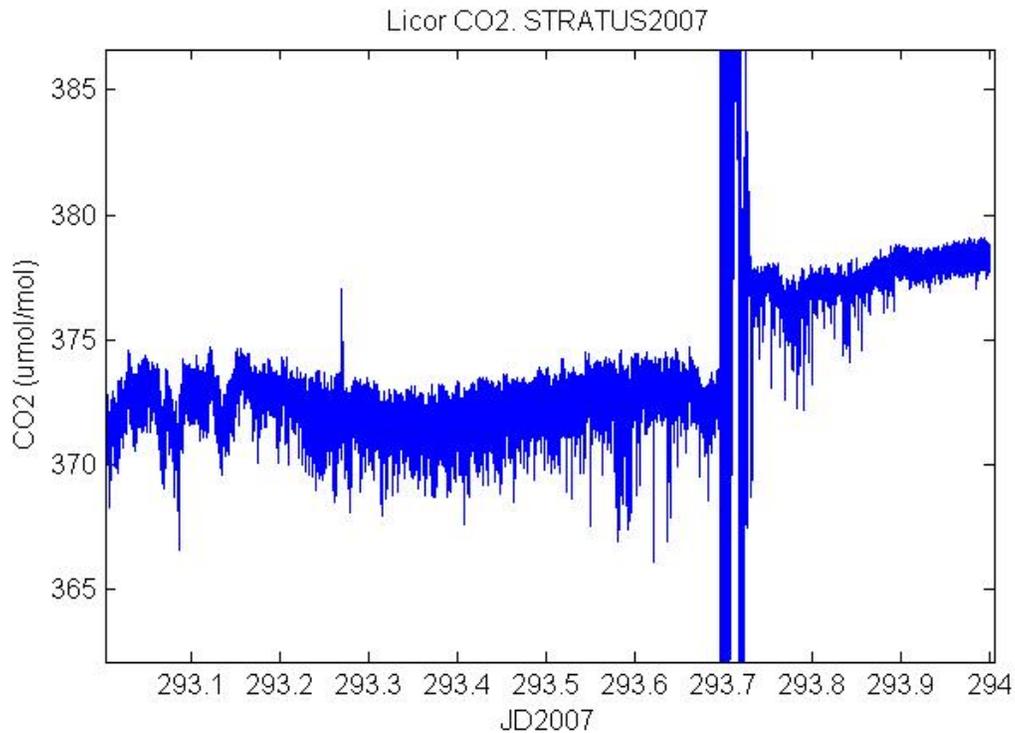
Figure 1. Time series of CO<sub>2</sub> from PSD open path LI-7500.

In this example the water washers were run for 10 sec at 293.7. This causes invalid data for several minutes but notice the change in the values after cleaning. Not only does the mean value change (increase) but the noise level is significantly reduced. Why? Not sure but suspect it is interaction of humidity variations and the microcrystals of salt on the optics. The second example is from JD 296 when the ship made several maneuvers later in the day that cause an exhaust plume to drift over the sensors. Here there are transients caused by the exhaust at roughly 296.6, 296.7, and 296.8. The first causes an obvious drop in mean CO<sub>2</sub>; the effects of the next two are less apparent. The fourth spike is associated with another washing, which restores the CO<sub>2</sub> to its previous values. Conclusions: a) ship exhaust quickly contaminates the windows and b) the effects seem to be alleviated by washing.

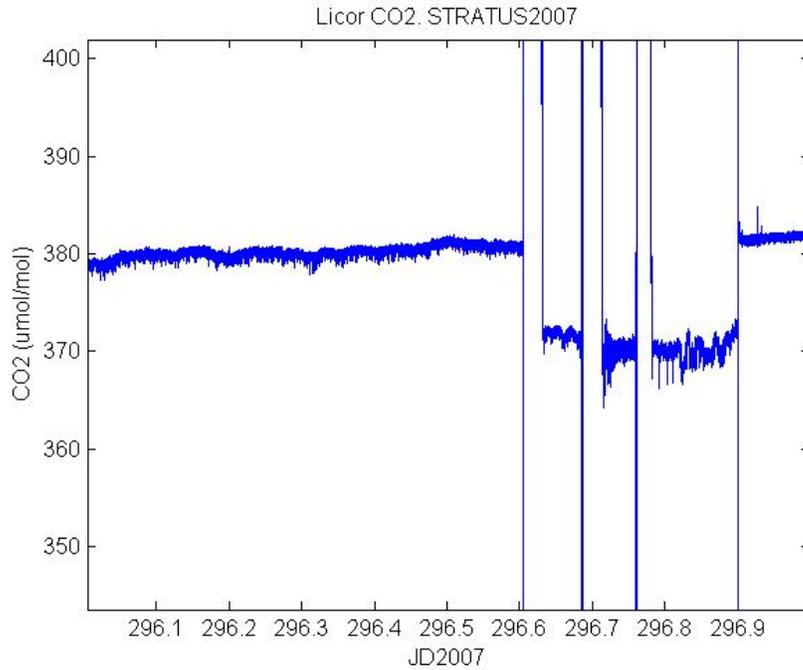
Figure 2. Time series of CO<sub>2</sub> from PSD open path LI-7500 showing ship plume effects and recovery due to washing.

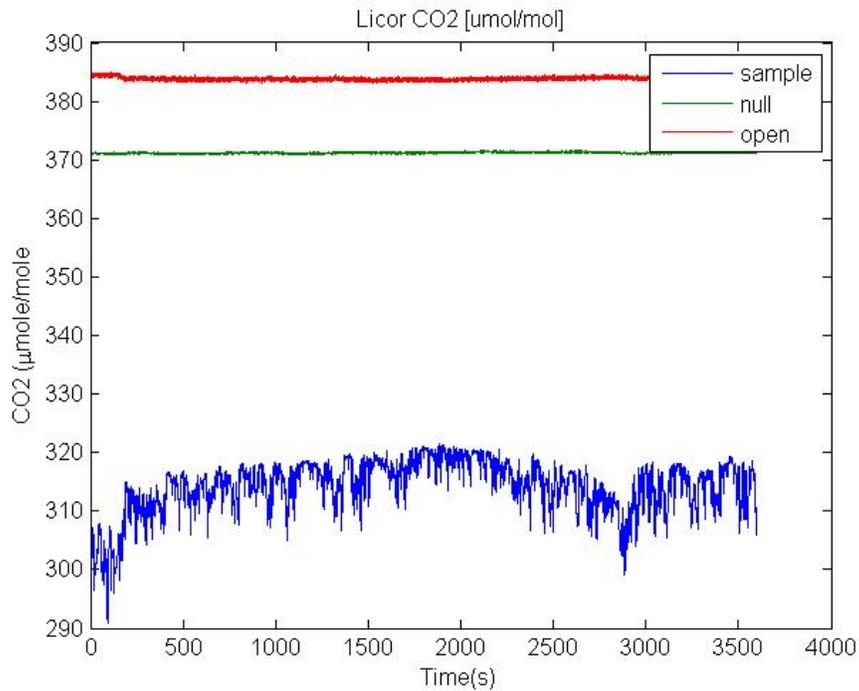
Figure 3. Time series of CO<sub>2</sub> from three LI-7500's: sample – blue line; null – green line; open – red line.

for CO<sub>2</sub> from the three units. The sample unit is obvious in severe distress with a poor mean reading and way, way too much noise. This could be because the unit is experiencing some hardware problems or it could be the effects of accumulated contamination. Right now we don't know, but will try to diagnose the issue by washing it when we can get to it (maybe the end of the cruise). This unit does not indicate noticeably degraded performance for water vapor but the significance of that is unclear.
