# SKQ201512S / SeaState DRI: Brief Analysis of Bulk Met Observations

Byron Blomquist, Ola Persson, Chris Fairall, Sergio Pezoa

NOAA ESRL/Physical Sciences Division  
And  
University of Colorado, CIRES

Nov 2015

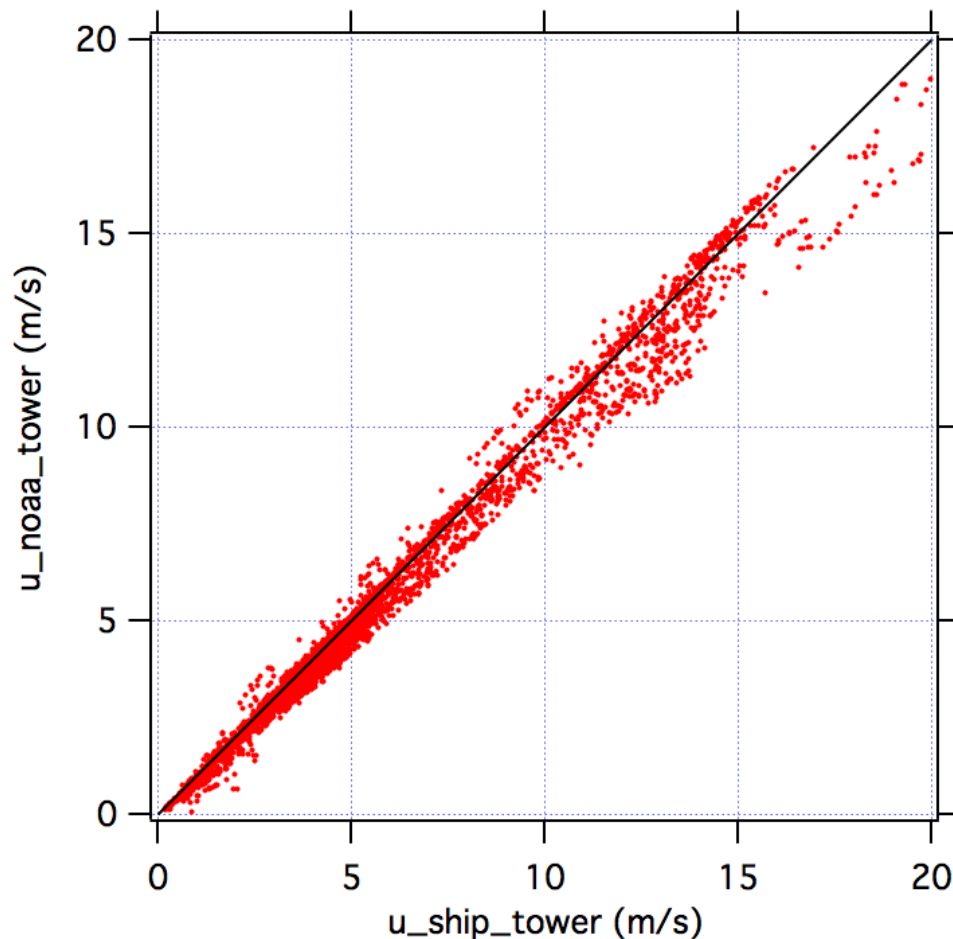
In general, wind speeds from anemometers on the bow tower compare very well (Figure 1).

Figure 1: True speed from bow tower sonic anemometers (10-min averages).

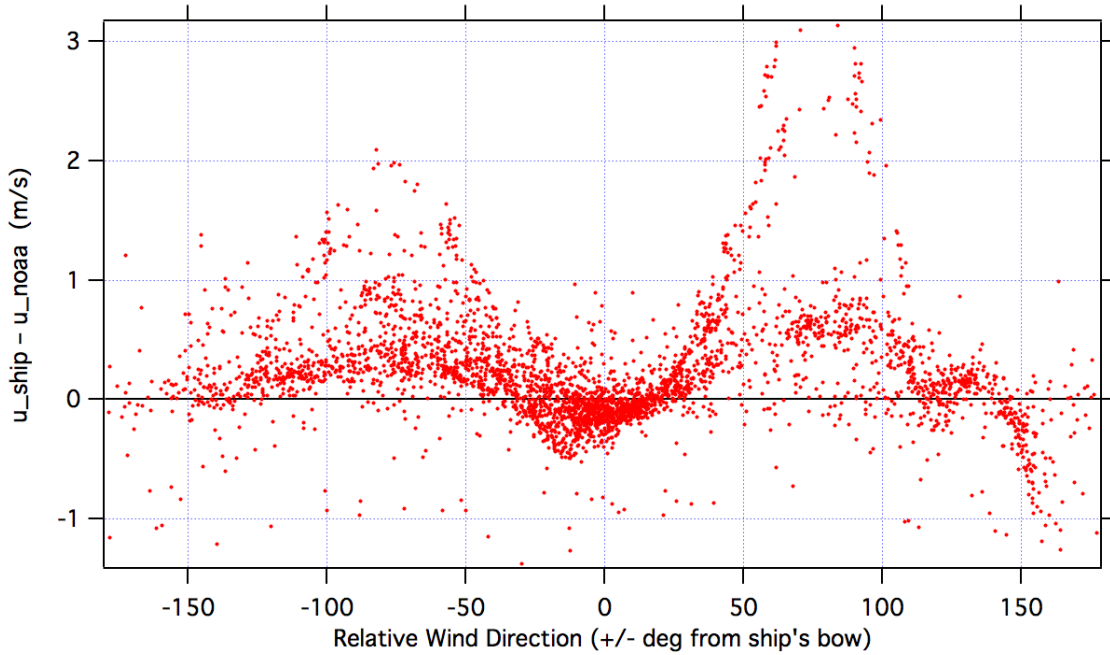
Differences between the ship and NOAA tower sonics are a function of relative wind direction, illustrating the effects of airflow distortion over the tower superstructure and differences that arise for even modest displacement distances between identical sensors (Figure 2). For wind from port or starboard directions the ship anemometer reads 1–2 m/s higher than the NOAA sonic. For bow-on winds the difference is much less significant. When the relative wind direction exceeds  $\pm 90^\circ$  neither sonic should be trusted; the main mast anemometers are likely better.

Figure 2: Difference in 10-min average true wind speed between the NOAA and ship tower sonics vs relative wind direction. Negative relative wind direction is to-port.

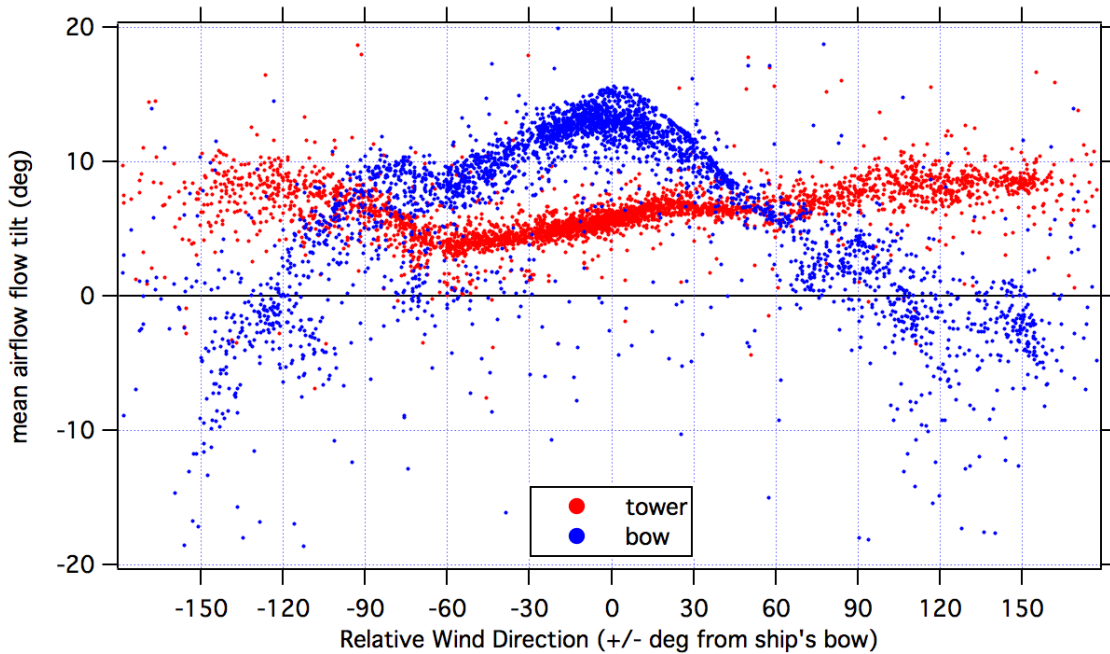
Airflow distortion is further illustrated by the observed flow tilt angle at the locations of the two NOAA sonics (Figure 3). The 5–7° flow tilt on the tower is comparable to most ships we have worked on. Flow tilt and distortion is strongly influenced by relative wind direction at the lower position on the bow davit. The true tilt angle for the lower sonic may be less than indicated because the sonic is mounted with a slight backward tilt.

Figure 3: Airflow upward tilt angle for the two NOAA sonics vs relative wind direction.

Flow distortion leads to a bias in true wind speed and direction. NOAA/PSD has determined correction factors for wind speed bias on the bow towers of several comparable research ships (Brown, Knorr, Revelle). We typically apply a correction factor of 0.95 to the U (fore-aft) wind component and a factor of 1.15 to the V (port-stbd) component. R/V Sikuliaq has a bit different wind profile from these ships and these correction factors may not be appropriate.

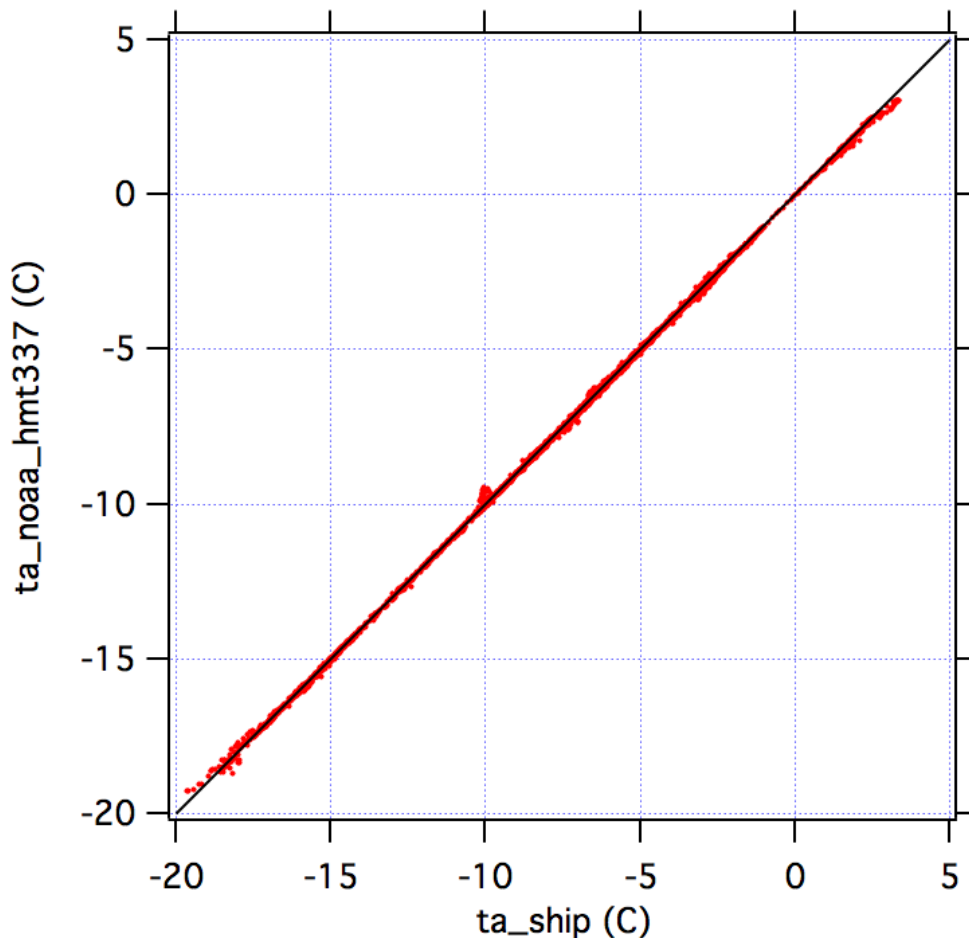
NOAA installed two T/RH systems at the top of the bow tower: an aspirated, non-heated T/RH probe (Vaisala HMT 335) and a similar non-aspirated system with separate T and heated RH probes (Vaisala HMT 337). The ship uses a 3-in-1 T/RH/P instrument (Vaisala PTU 307), also with separate T and heated RH probes. The PTU 307 and HMT 337 sensors were mounted within 1 m of each other on the port side of the tower. The HMT 335 was on the starboard side of the tower platform. Air temperatures from the 3 systems agree to within 0.2°C. Comparison of the HMT 337 and PTU 307 systems is shown in Figure 4.

Figure 4: Comparison of NOAA HMT 337 and ship PTU 307 air temperature.

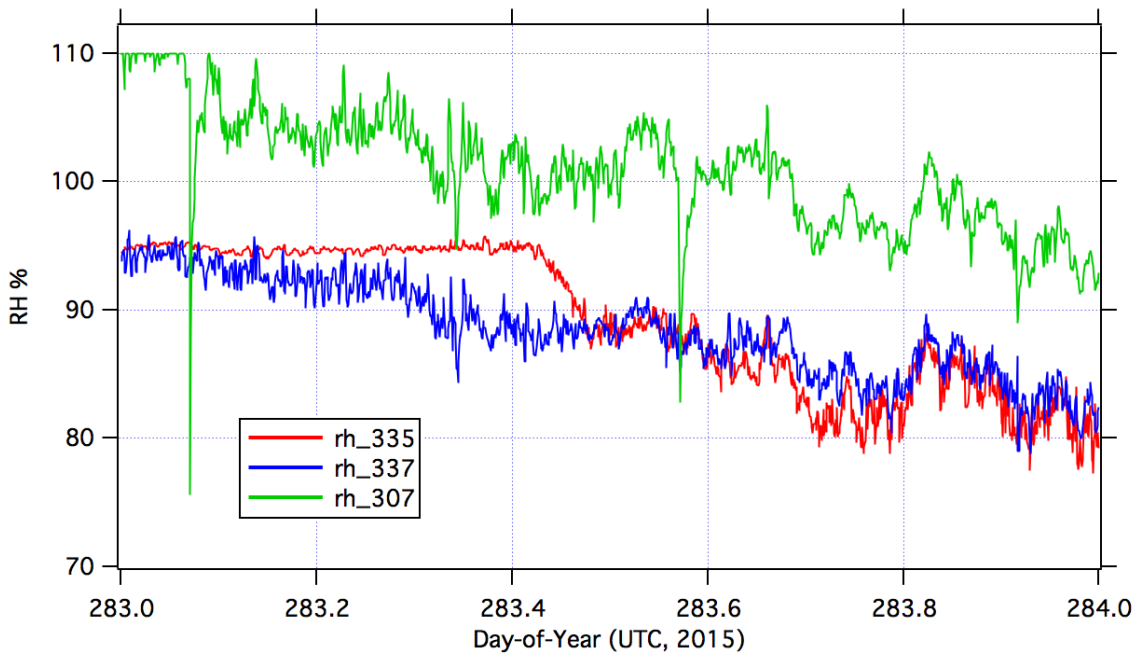
The two NOAA RH sensors (HMT335 and 337) generally agree within ~2% except for periods when the unheated HMT 335 sensor is iced up, as in Figure 5 during the first half of day 283 (Oct 10). The ship PTU 307 RH shows more variability than the NOAA HMT 337 and is generally biased high by 10–15% RH, exceeding 100% RH much of the time. Figure 6 shows that the difference is not a simple bias. The ship's RH probe should be recalibrated or replaced as necessary. The source of the occasional large downward spikes in the PTU 307 is unknown.

Figure 5: RH time series for Oct 10 (DOY 283)

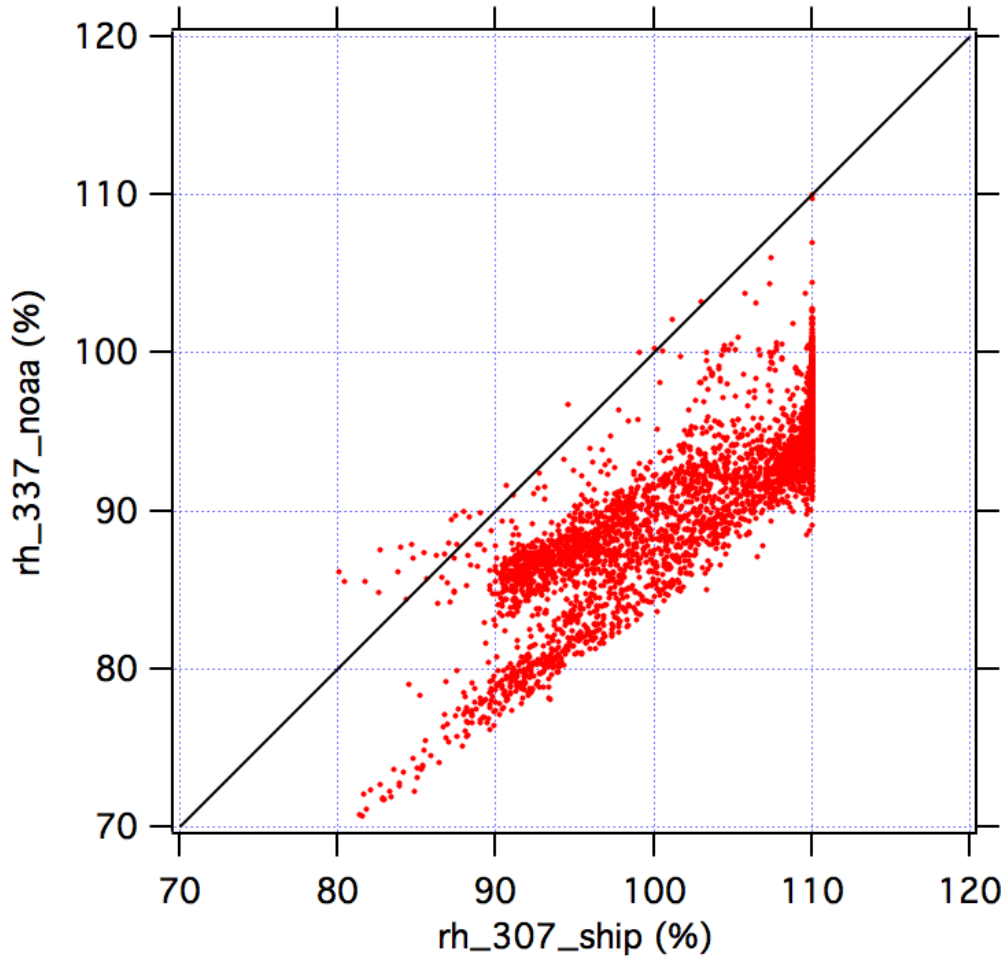
*Figure 6: Comparison of HMT 337 and PTU 307 relative humidity.*

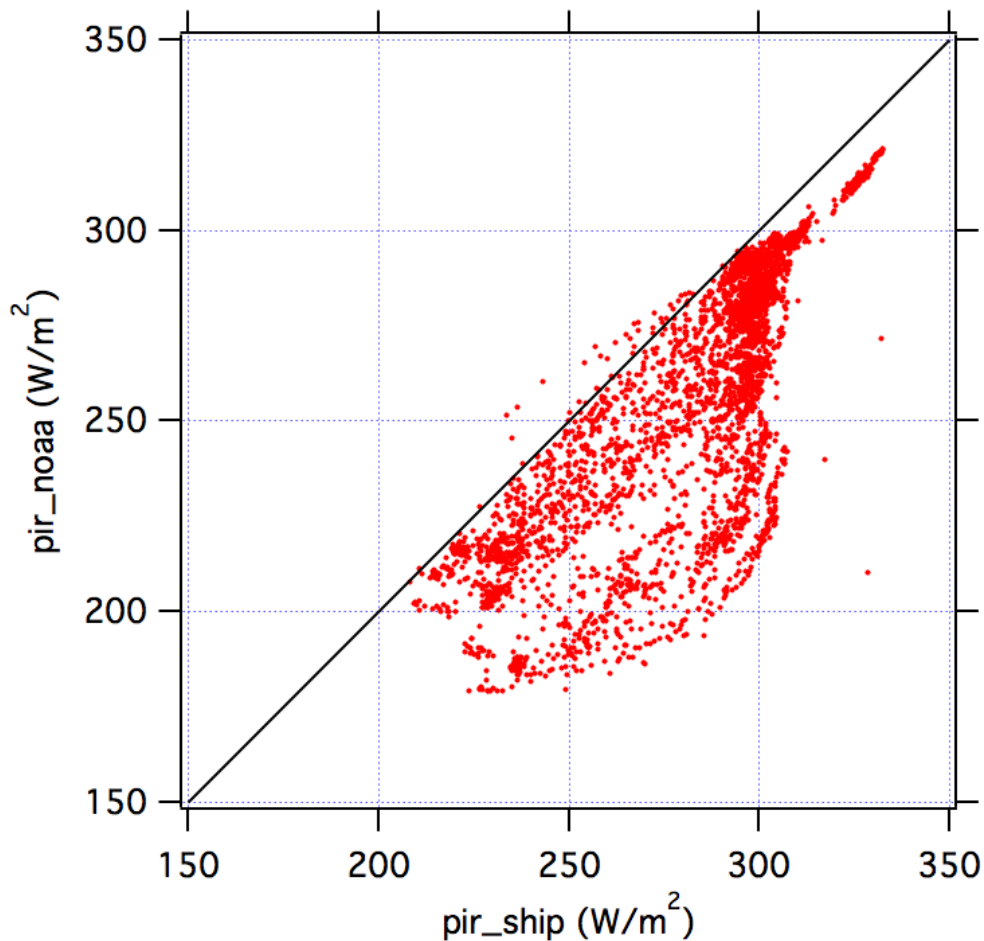
The two locations are undoubtedly subject to different shading and interference patterns, which we plan to evaluate as part of the post-cruise analysis. At times the IR measurements are comparable but often the ship sensor is more than  $50 \text{ W/m}^2$  higher than the NOAA PIRs (Figures 7 & 8).

Figure 7: Comparison of ship and NOAA IR flux.

Bias in the ship PIR is due to bad case and dome temperatures. On DOY 300 (Oct 27), for example, case and dome temperatures in the raw file are constant at about  $-2.8^{\circ}\text{C}$  all day while air temperatures varied from  $-11$  to  $-16^{\circ}\text{C}$ . There's clearly a problem with the ship's PIR temperature sensors or the RMR logger. At night and in cloudy conditions PIR case and dome temperatures should closely follow the air temperature. In clear sunlight they will be a bit warmer than air temperature. The IR correction can be recomputed from the raw data substituting observed air temperature or case/dome temperatures from the NOAA PIRs.

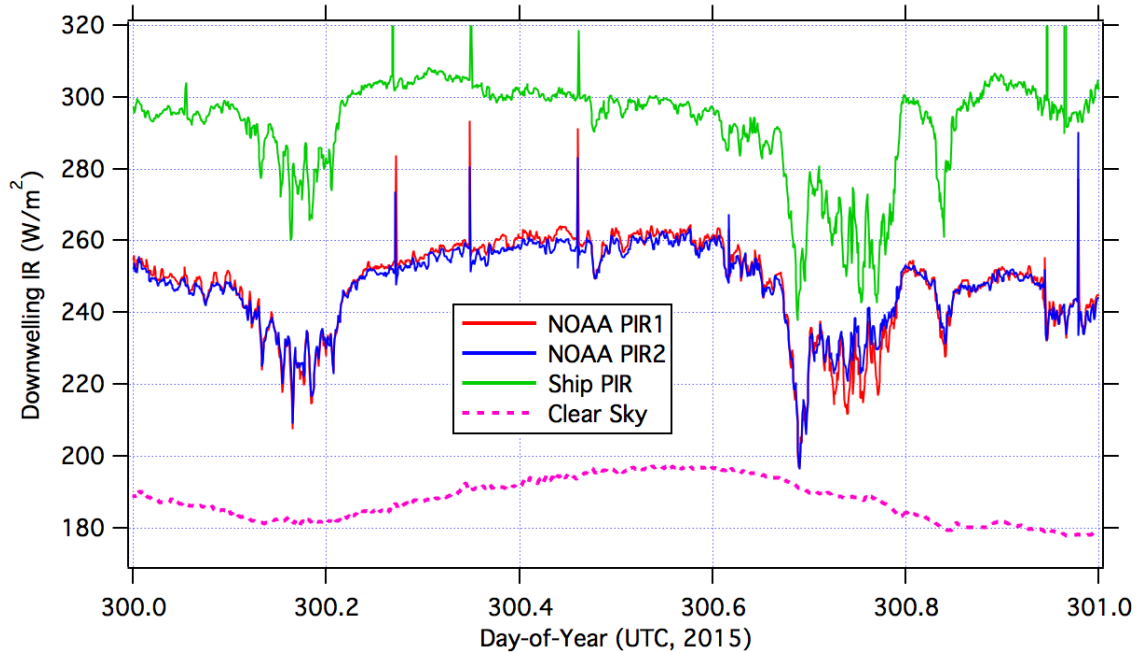
*Figure 8: Comparison of downwelling IR on a generally cloudy day with little or no sensor icing. Sharp positive spikes are heat from hand cleanings. Breaks in cloud cover are downward spikes. 'Clear sky' is the expected IR flux for cloud-free conditions for this latitude at ambient temperature and specific humidity.*

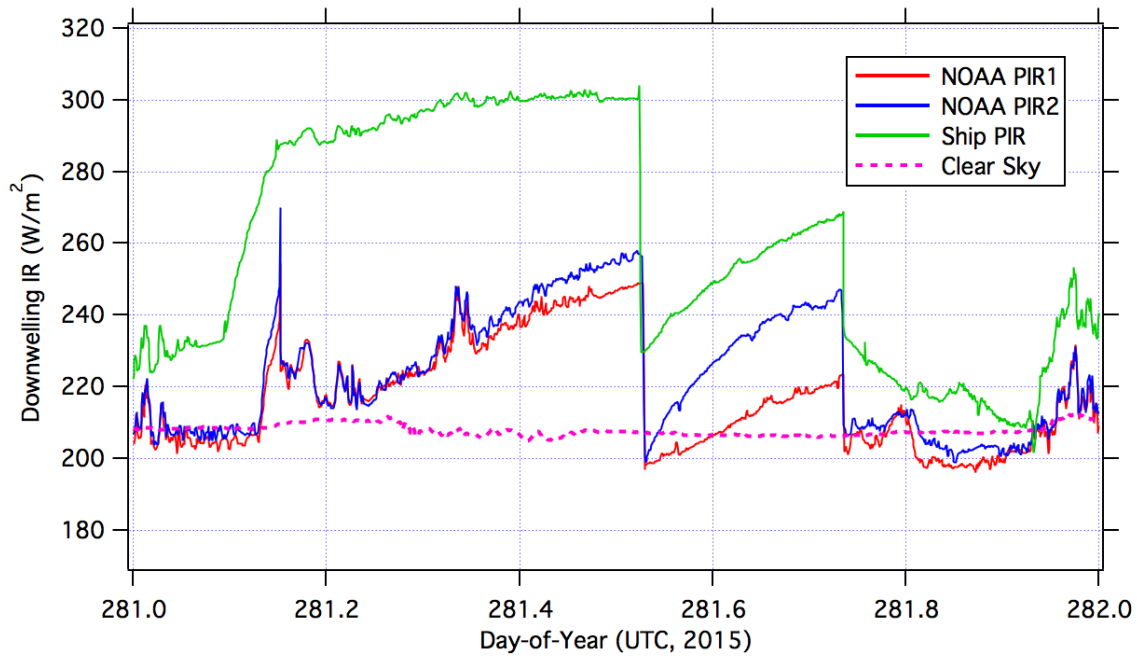
The effects of sensor icing are illustrated in Figure 9. This is the most significant problem for radiation measurements in cold conditions. For the PIR it is greatest on clear, cold days when IR flux should approach the expected clear sky value. Instead, the sensor sees IR emission from the frost at roughly the ambient air temperature, which is warmer than the clear sky blackbody temperature leading to positive bias.

*Figure 9: Comparison of downwelling IR on a clear day (Oct 8) with significant sensor icing. The observed IR flux should be close to the theoretical clear sky value. It increases significantly as frost forms on the sensor dome, dropping to the clear sky value following each a cleaning. On this day the NOAA PIR1 shows a bit less frost formation. Frost conditions abate toward the end of the day, which is near the local solar noon.*

To fill in periods of frost-affected data we can use the clear sky IR value for cloud-free days, validated by the occasional good PIR value immediately following a cleaning. On days with patchy cloud we will need to rely on the readings immediately following cleaning and interpolate for periods when the sensor is frosted. Cloud base temperature (or ambient air temperature in foggy conditions?) should represent the maximum expected downwelling IR flux.

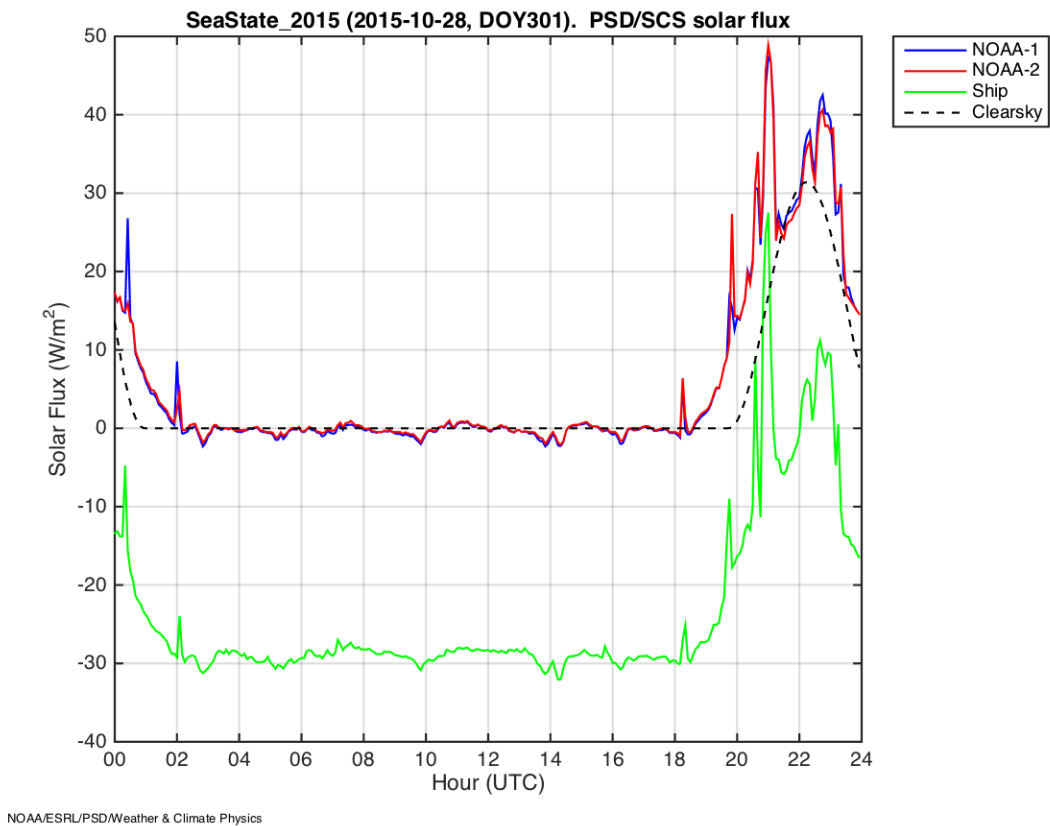
The ship PSP shortwave flux shows a large negative bias relative to the two NOAA radiometers (Figure 10). Nighttime shortwave flux should be near zero or a few watts negative. The linear correlation between the PSP sensors looks fine (Figure 11), with the ship PSP biased low by about  $29.5 \text{ W m}^{-2}$ . The scatter around the straight line is believed to be due to shading effects at the two different locations; this will be verified from further analysis of cruise data.

Figure 10: PSP solar flux for DOY 301 (Oct 28).

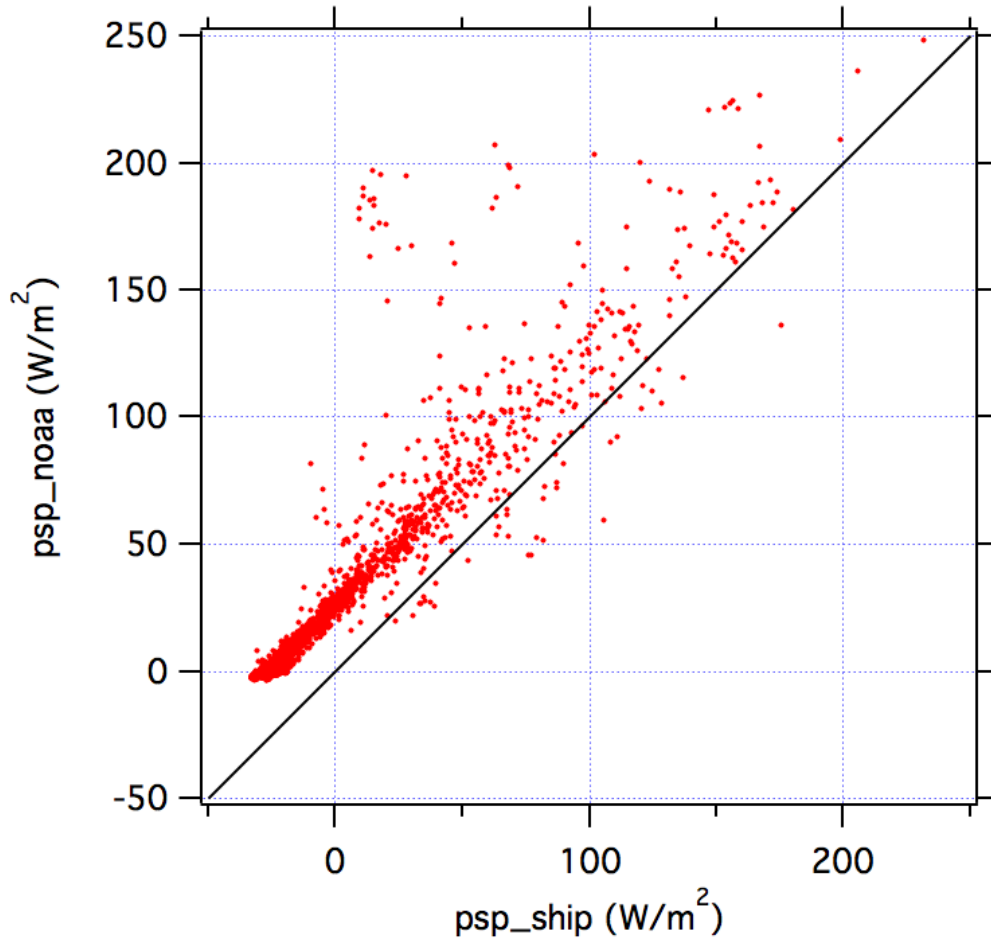
Figure 11: Comparison of ship and NOAA solar radiation sensors.

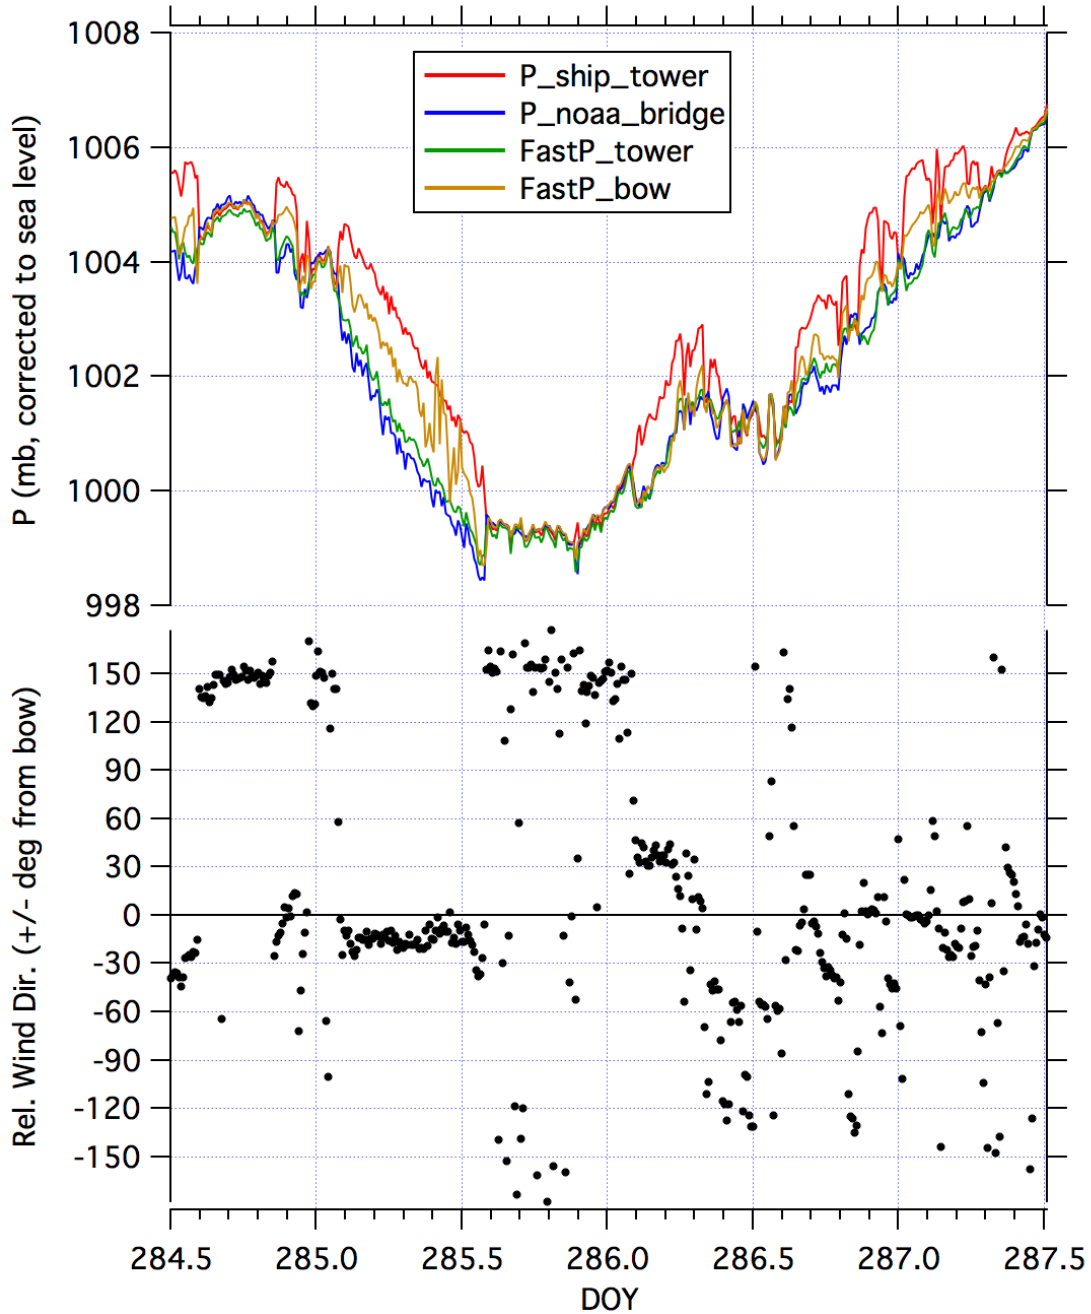
Corrected to sea level the four pressure sensors agree to within  $\sim 0.2$  mb under calm conditions or when the relative wind direction is from aft. For wind speeds in excess of  $\sim 5$  m/s the pressure measurements diverge by more than 1 mb, illustrating the effects of airflow distortion noted in the discussion on wind speed (Figure 12).

It's interesting to note the ship pressure and NOAA fast pressure from the tower top differ by more than 1 mb in moderate winds even though they are mounted less than 1 m apart. There's clearly a local flow distortion over the tower platform affecting both wind speed and pressure measurements. Elevating the anemometers and pressure inlets 1-2 m above the platform can minimize this. It's also desirable to use an omnidirectional pressure inlet to minimize dynamic pressure effects at the inlet tip.

Figure 12: Pressure data for DOY 286, correct to sea surface. When relative wind is in the  $\pm 60^\circ$  sector the various pressure measurements differ significantly due to flow distortion and dynamic pressure gradients over the ship superstructure. When wind is from the ship's stern turbulence over the front of the ship largely eliminates the pressure gradients and the four sensors show close agreement, as they do during calm conditions.

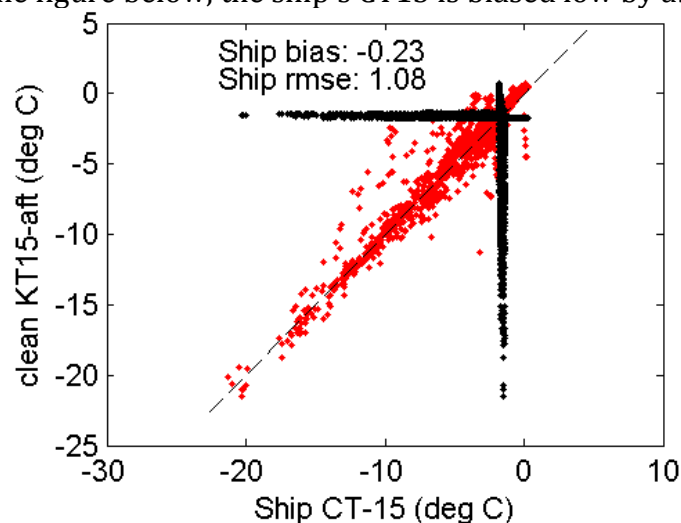
The ship's infrared surface skin temperature was in good agreement with the NOAA-deployed KT-15 IR thermometers, with apparently less riming/icing problems. In the figure below, the ship's CT15 is biased low by about  $0.2^{\circ}\text{C}$ .

**Figure:** Comparison of aft KT-15 IR surface temperature and the ship's CT-15 IR surface temperature (red points). Only times when both sensors are clean are used. Black points show the freezing point of seawater at the observed salinities from the ship's thermosalinograph; points colder than this are ice/snow surface measurements.

Though all attempts were made to compare only times when all IR instruments were clean, it was difficult to assess the state of the ship's CT15 lens due to the long barrel. This barrel did get full of ice with strong winds on the starboard beam in open water, resulting in a significant low bias to its signal (data from this time period is not used). The remaining scatter may be due to either additional riming issues on either the CT-15 or the KT-15 sensors, or to a possible thermal impact (and solar radiation impact) on the measurement of the CT-15. The KT-15 sensors have a measured thermal correction of a few tenths of a degree, which the CT-15 sensor does not.

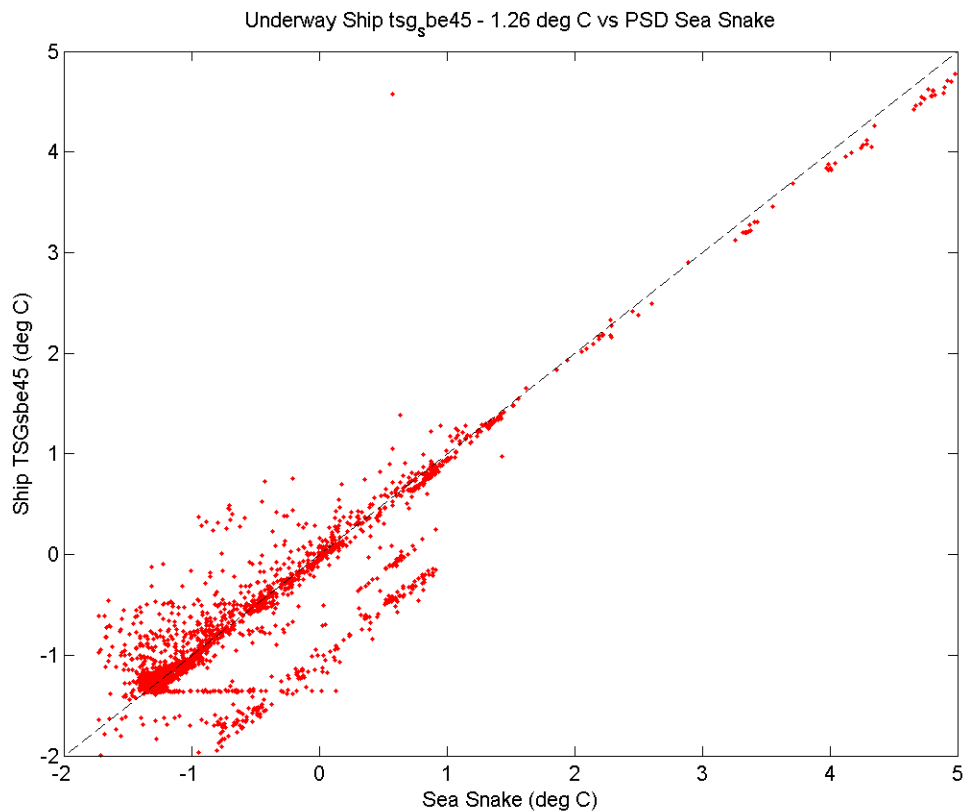
The ship's thermosalinograph (TSGsbe45) generally has a high bias of  $1.26^{\circ}\text{C}$  compared to the PSD near-surface in-situ sensor (sea snake) when the latter is in open water. Some of this difference may be real because of the 6.5 m depth of the sampling from the thermosalinograph, but there is in general a constant bias. The figure below corrects for this  $1.26^{\circ}\text{C}$  bias.
