Installation Report

Ref.: POSMV Installation aboard Kilo Moana

During the period of March 2nd through 8th, a POSMV system commissioning and calibration was conducted aboard SOEST vessel *Kilo Moana*. The following are a summary of events and final observations.

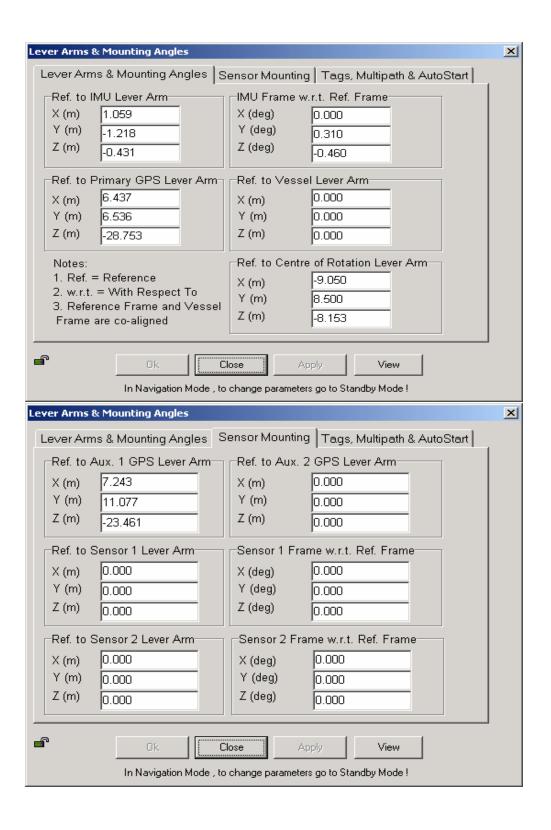
Lever Arm installation page on POSMV controller:

- 3. The only change to the lever arm entries was a correction to Z value for the Ref to Pri GPS antenna location. The Blom survey indicated this point was -28.969 above the granite block and when the old antenna was removed it was noted that the reflex target was fixed to the base of the shroud tip. From this we concluded that the actual phase center of the antenna was not taken into account in the initial lever arm measurement. The new antenna is mounted 21.59cm below the point where the reflex target was measured on the old antenna so as a result, the elevation value for the new antenna is now -28.754m. The rest of the lever arms are consistent with the Blom survey results.

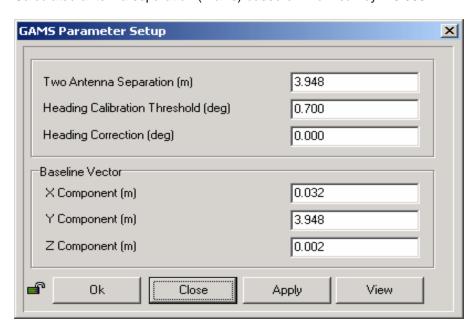
Observed antenna separation derived from GAMS calibration.

Calculated antenna separation (X axis) based on Blom survey = 0.031 m Calculated antenna separation (Y axis) based on Blom survey = 3.955 m Calculated antenna separation (Z axis) based on Blom survey = 0.005 m

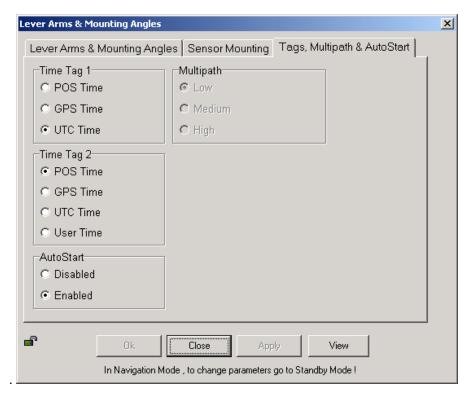
Multipath setting is fixed at LOW as this was deemed to be the most effective.

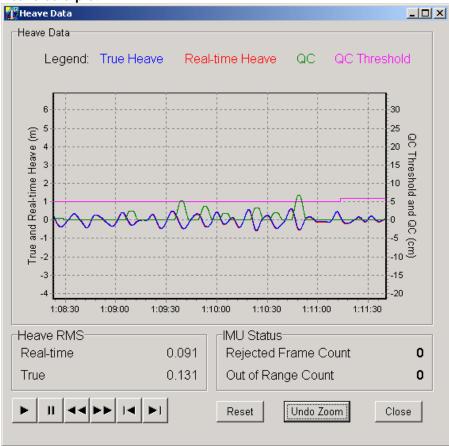
Heave data plot:

The heave plot above shows the relationship between the Real-time (RT) heave and the True (or delayed TH) heave measurements. The green line relates to quality control (QC) and represents the difference between the two values. When the delta between the RT and TH exceeds 5cm or 5% of total heave (pink line) then the radio light on the main controller screen will turn from green to red but does not affect the real-time heave data being collected. Quite often this occurs after the vessel makes a turn or an abrupt change in speed and is not necessarily cause for alarm. The heave filter has a 105 second buffer so the event which may have caused the impulse happened in the past. A red light merely calls the users attention to the difference and may also suggest that the filter settings need to be refined if the QC value is continually out of bounds.

Note: The TrueHeave data filter is delayed about 3 minutes from the TH value. <u>Also, Group 111 & 113 must be enabled in the Ethernet Real-time logging page.</u>

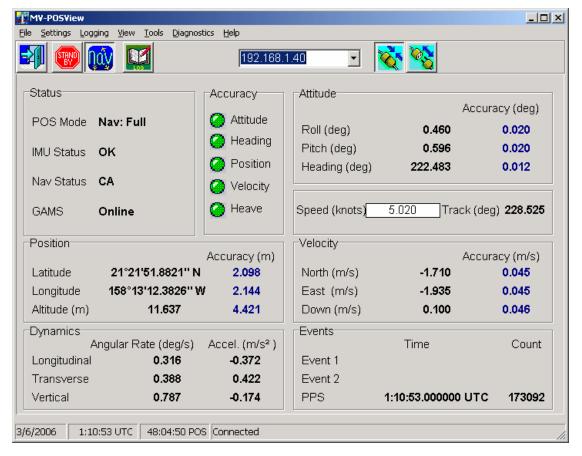
The main controller screen below shows normal POSMV operation. POS Mode is FULL indicating that all user accuracy settings have been satisfied.
