Observations of Licor Issues  
Stratus Cruise  
October 2007

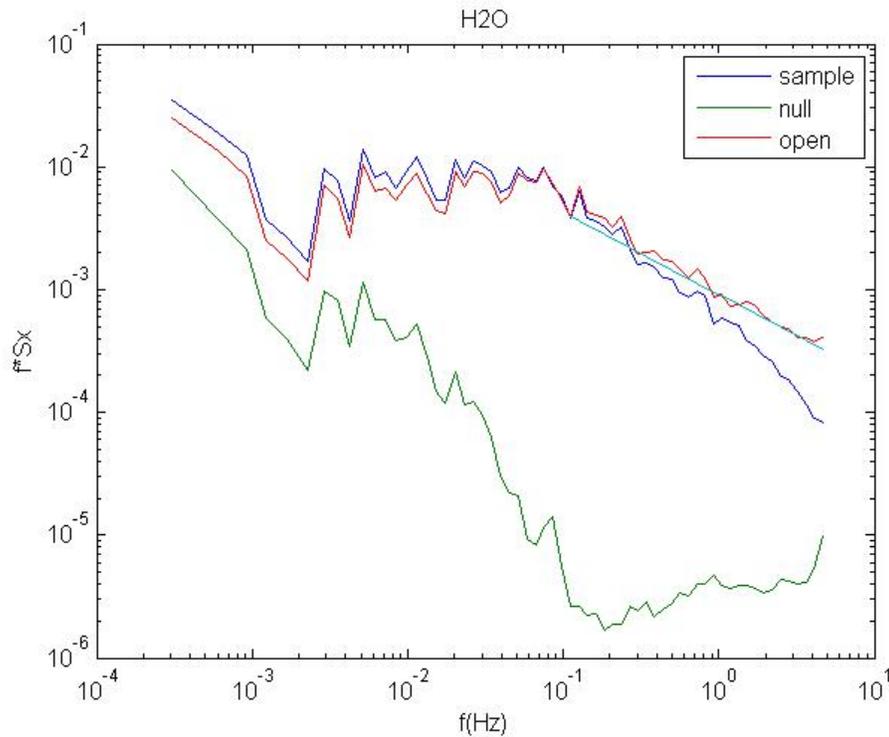
The sample/null approach is our approach for a more robust and weatherproof CO<sub>2</sub> measurements. We need to characterize the filter function for the sample unit and we need to be able to ensure that the null removes most of the real atmospheric variations above the frequency where the motions affect the CO<sub>2</sub> signal. The water vapor signal is a good way to look at the sample filter function (Fig. 4). In this case the sample unit is about 20% more sensitive than the open unit (thus the constant offset at low frequency). The filter effect of the ventilation is seen as relatively reduced signal as frequency increases.

Figure 4. Variance spectra for the water vapor signals; one hour of data. The short green straight line is the -5/3 inertial subrange slope.

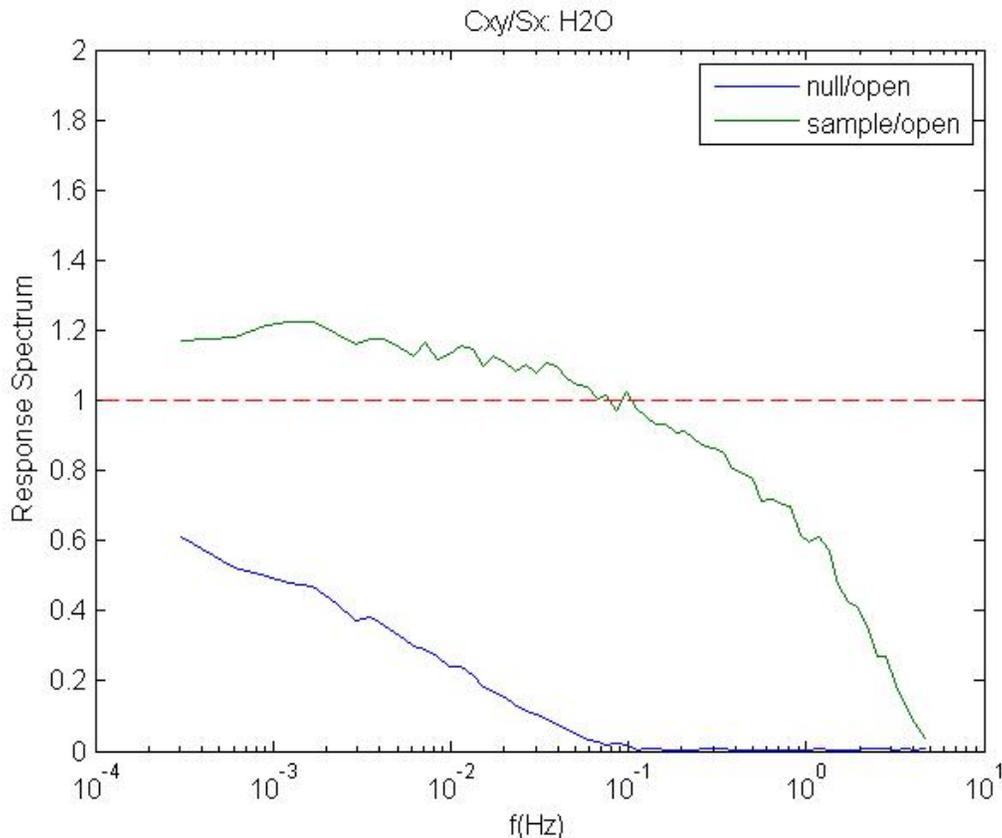
Figure 5. Ratio of cross correlation of null (blue) and sample (green) with the open signal divided by the open variance spectrum.

At low frequency the ratio is 1.2, which is the ratio of water vapor fluctuation sensitivities of the two devices. The decrease with frequency is a combination of uncorrelated noise, spatial separation, and the ventilation filter function. This graph suggests the filter for the sample sensor has a characteristic frequency of about 0.4 Hz. It is more difficult to characterize the cutoff frequency of the null system. I don't think it behaves like a simple filter. It looks like most of the signal is gone by 0.02 Hz. We put a flow restrictor on the hose several days ago but I haven't looked carefully enough to say if that changed things. Fig. 6 is an example of humidity time series. You can see the fine structure has been removed by the filter volume. Also, the null and the open agree well for mean humidity with the Vaisala unit. You can also see the sample unit has slightly more variability than the open unit – the ratio of 1.2 referred to above. Furthermore, the ratio of mean humidity of sample to open is 1.22. This implies that, in this particular case, the humidity error of the sample unit is in gain instead of offset.

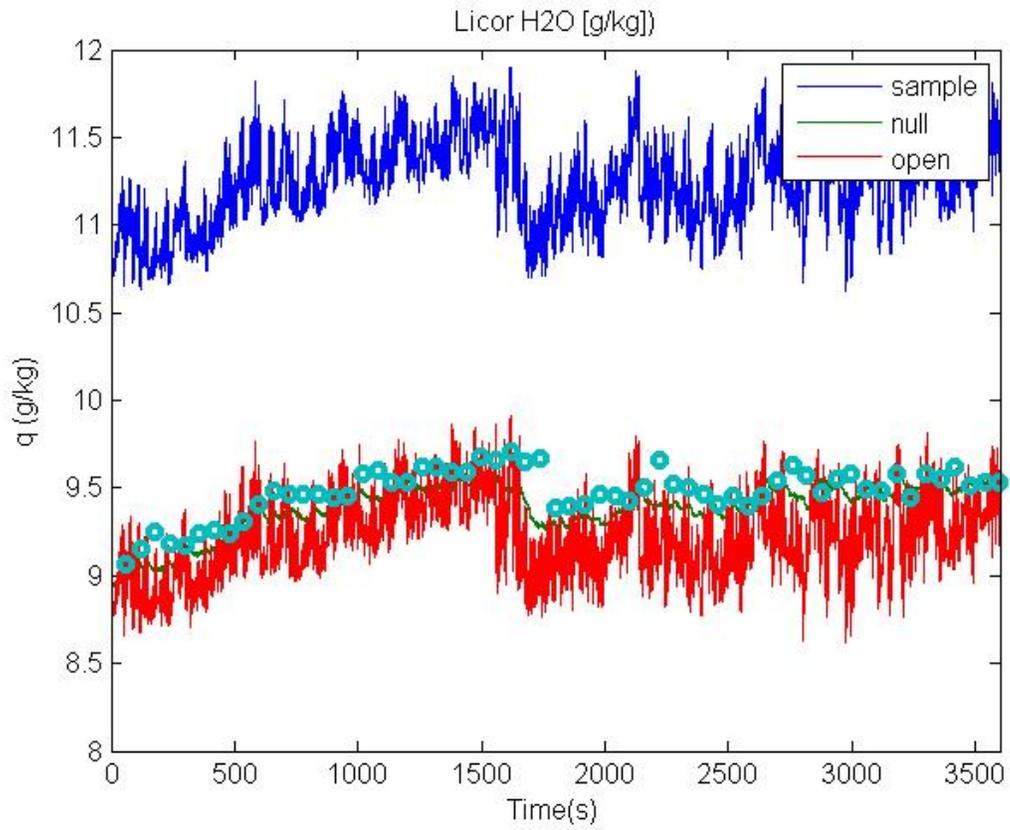
Figure 6. Time series of specific humidity from LI-7500 (sample – blue; open –red) ‘null’ - green) and Vaisala HMP325 (circles) .
